Title: Wind performance testing of 2mm Composite panels for Newbrel Limited.

Report No: N950-25-18939

Issue date: 01 May 2025

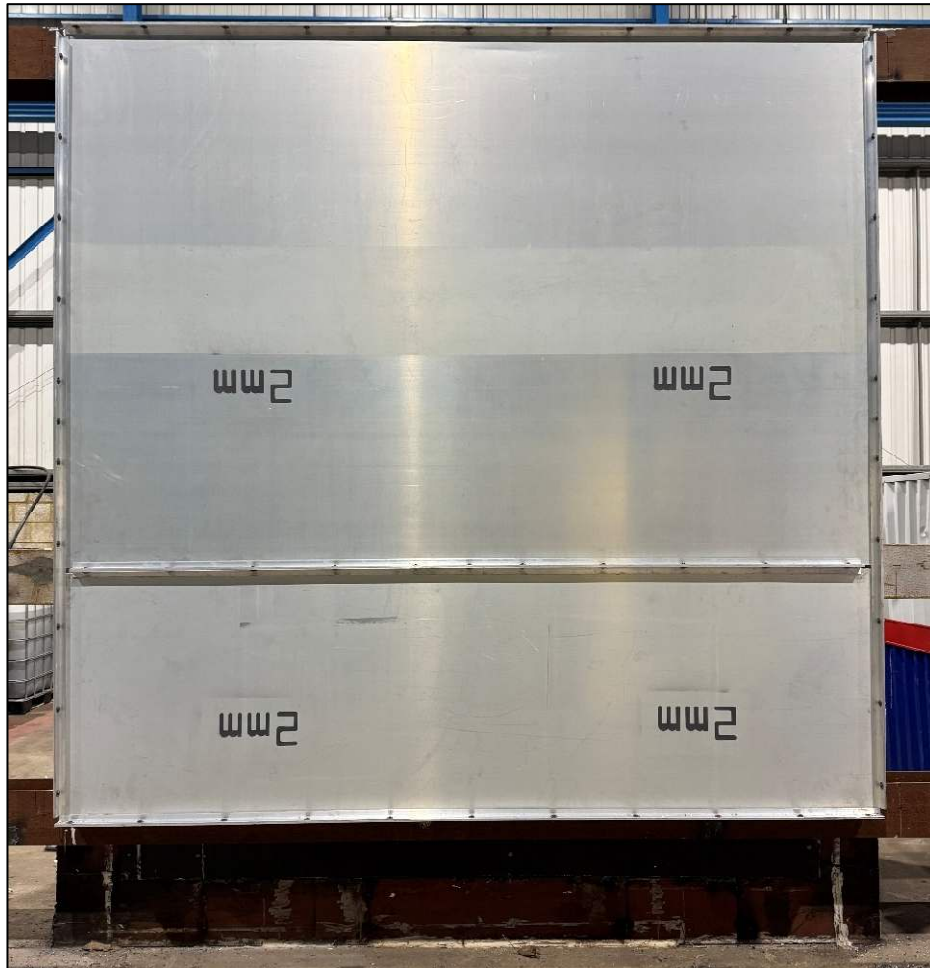
PHOTO 3335

The sample was as shown in the photo below. The following details apply:

Façade type 2mm Composite spandrel panels

TEST SAMPLE ELEVATION

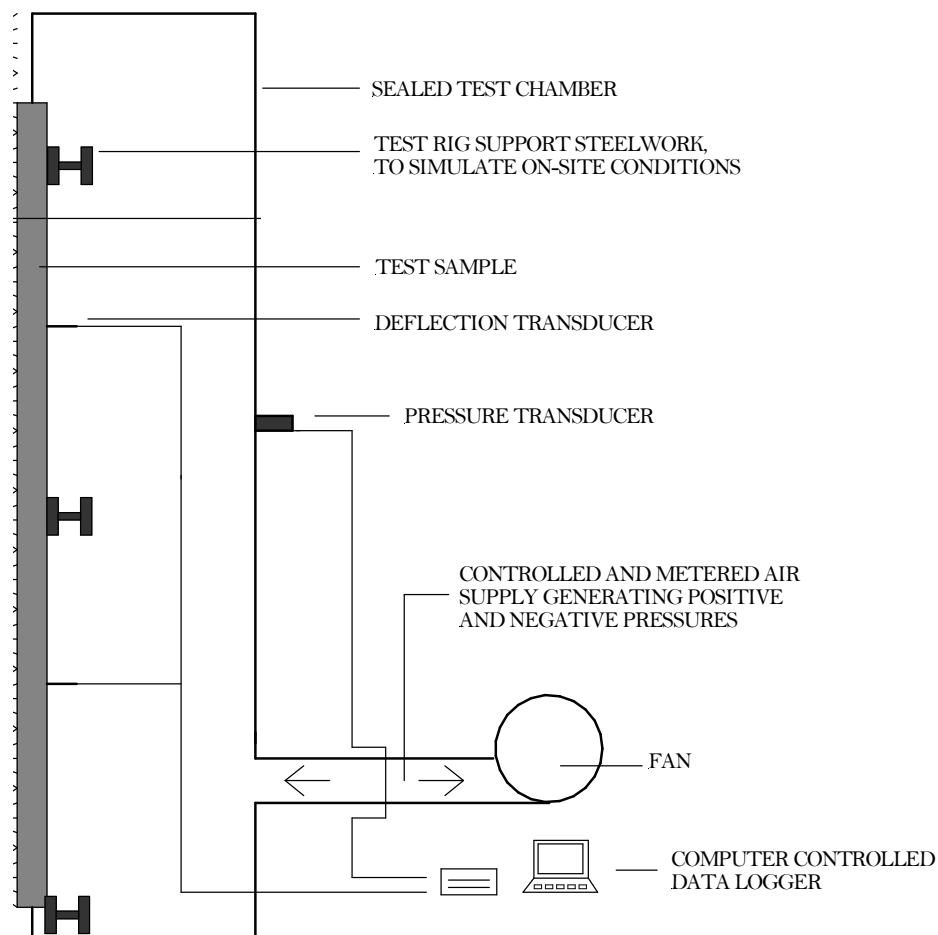
FIGURE 1

The test sample was mounted on a rigid test rig with support steelwork designed to simulate the on-site/project conditions. The test rig comprised a well sealed chamber, fabricated from steel and plywood. A door was provided to allow access to the chamber. Representatives of Adept Facades Limited installed the sample on the test rig. See Figure 1.

TEST RIG SCHEMATIC ARRANGEMENT

SECTION THROUGH TEST RIG

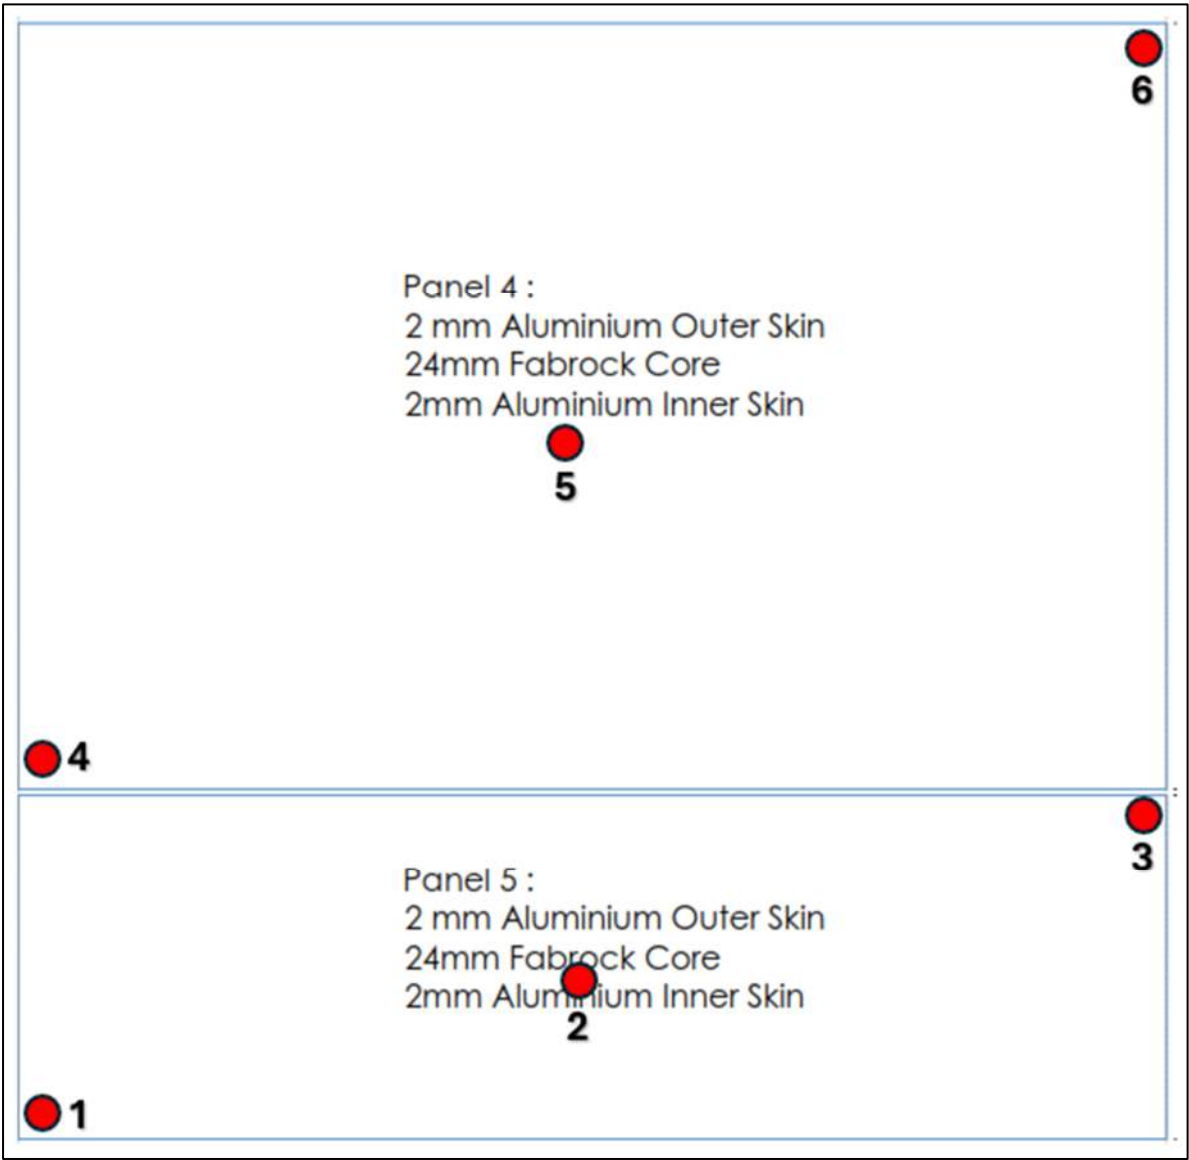
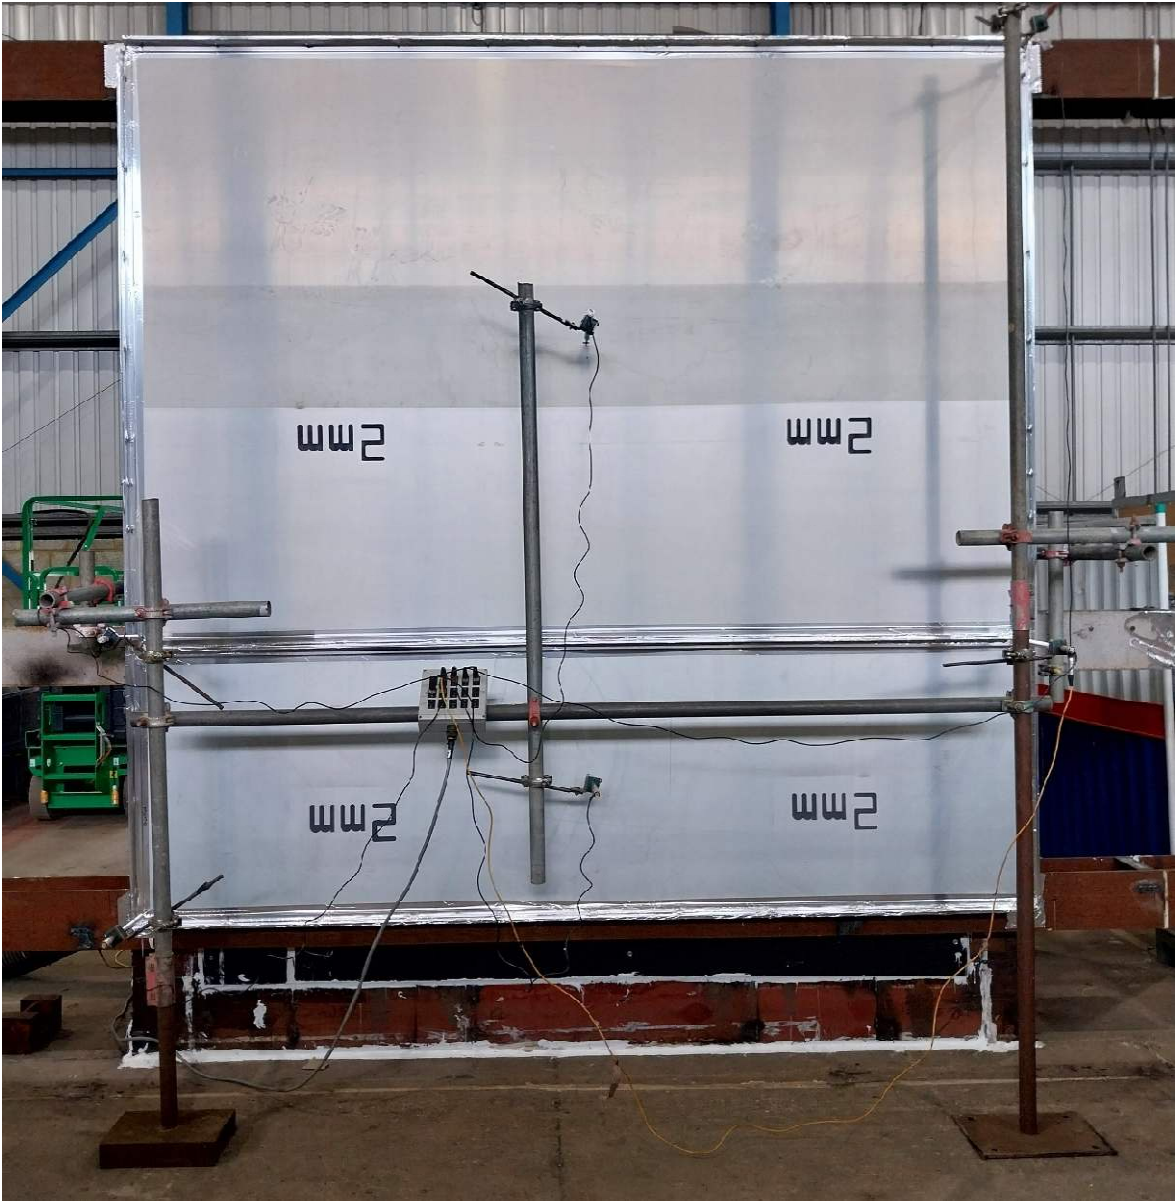
FIGURE 2

Displacement transducers were used to measure the deflection of principle framing members to an accuracy of 0.1 mm. The gauges were set normal to the sample framework at mid-span and as near to the supports of the members as possible and installed in such a way that the measurements were not influenced by the application of pressure or other loading to the sample. The gauges were located at the positions shown in Figure 2.

DEFLECTION GAUGE LOCATIONS

External View

GAUGE LOCATIONS ON SAMPLE

Gauge number	Position on panel	Span (L)	Measured deflection	Measured residual deformation
2	Centre	3050 mm	1.6 mm (L/1906) -1.6 mm (L/1906)	0.0 mm -0.1 mm
5	Centre	3500 mm	10.9 mm (L/321) -10.6 mm (L/330)	0.1 mm -0.1 mm

Gauge number	Position on panel	Span (L)	Measured deflection	Measured residual deformation
2	Centre	3050 mm	2.2 mm (L/1386) -2.2 mm (L/1386)	0.0 mm -0.1 mm
5	Centre	3500 mm	17.6 mm (L/199) -18.1 mm (L/193)	0.4 mm -0.2 mm

The deflections measured during the wind resistance test, at the positions shown in Figure 2, are shown in Tables 4 and 5.

The deflections measured during the structural safety test, at the positions shown in Figure 2, are shown in Table 6.

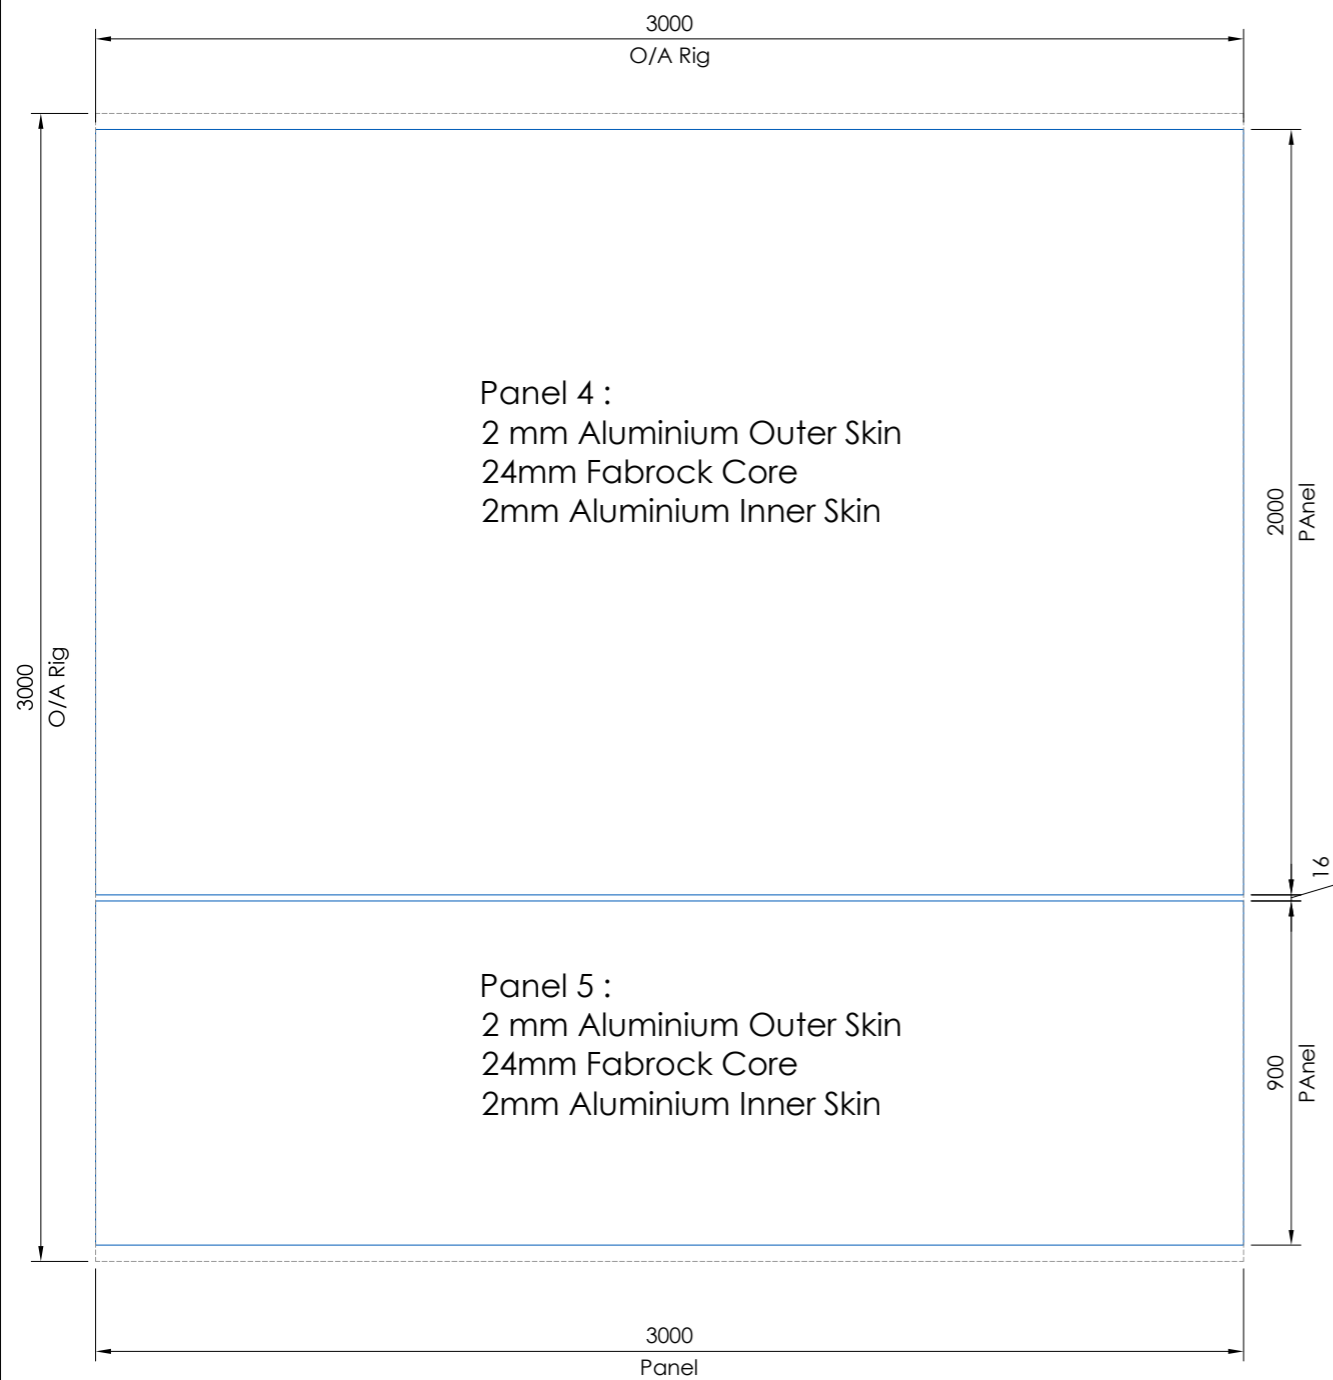
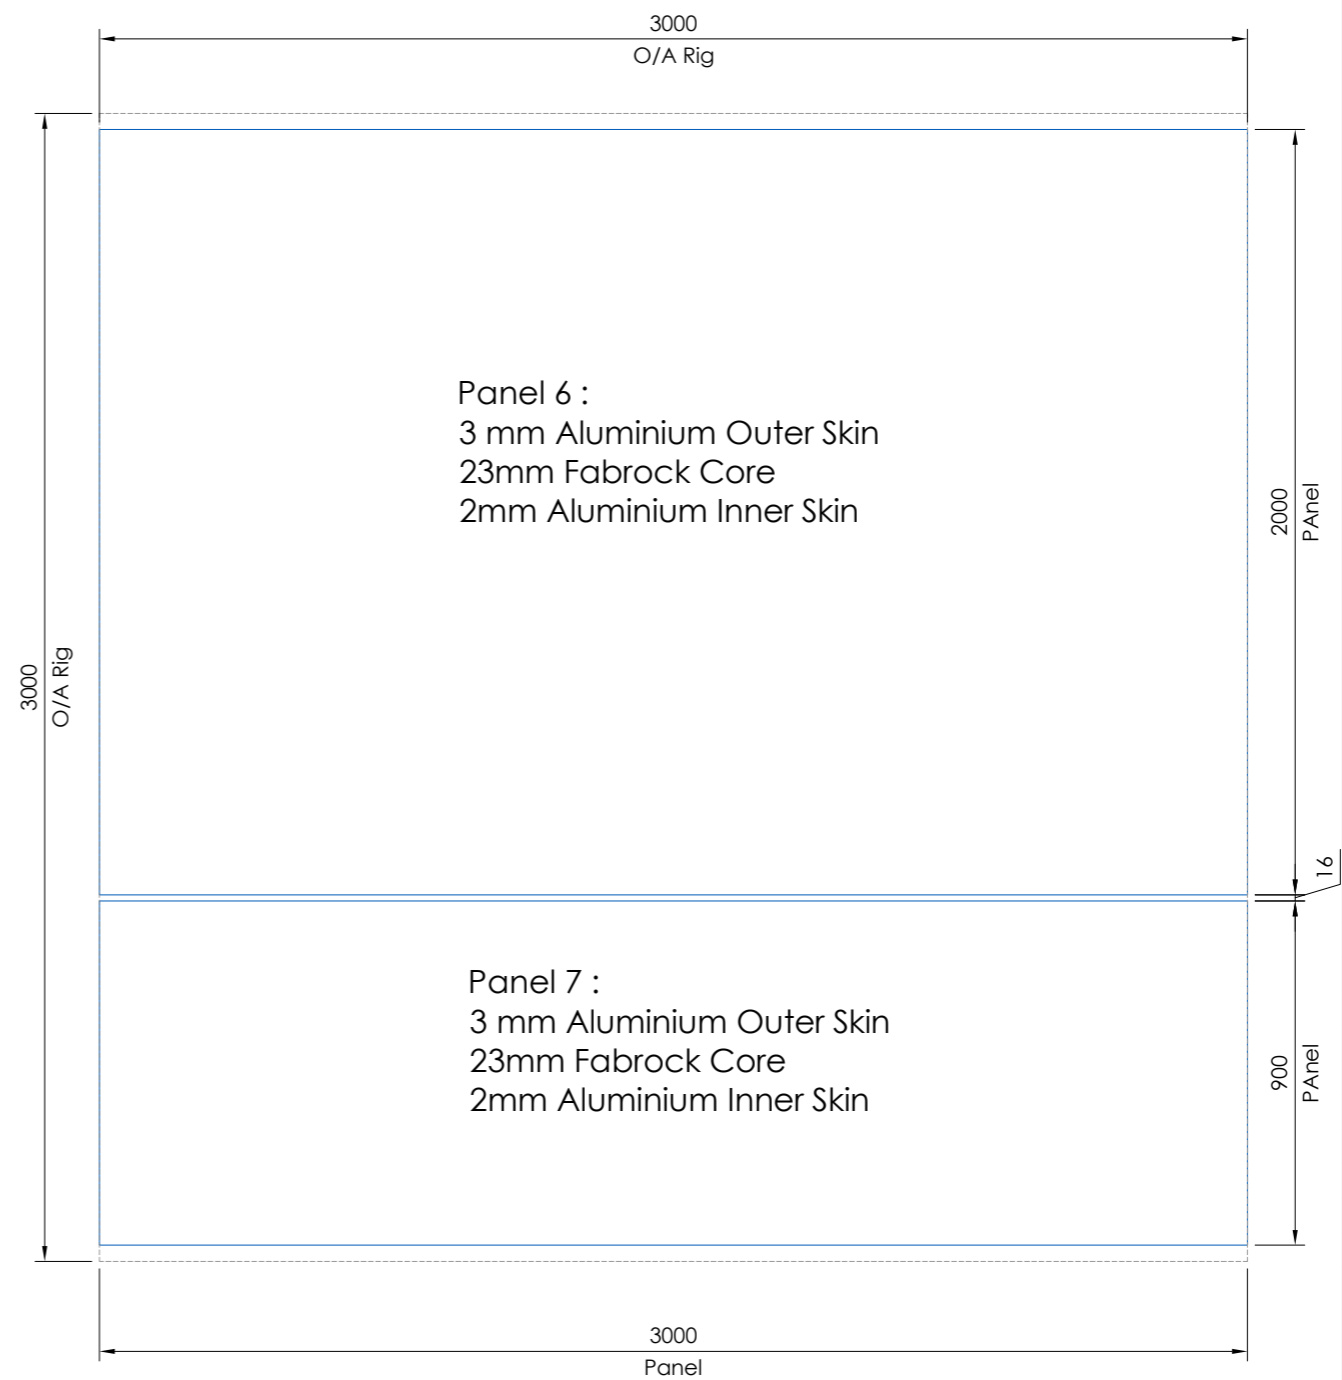
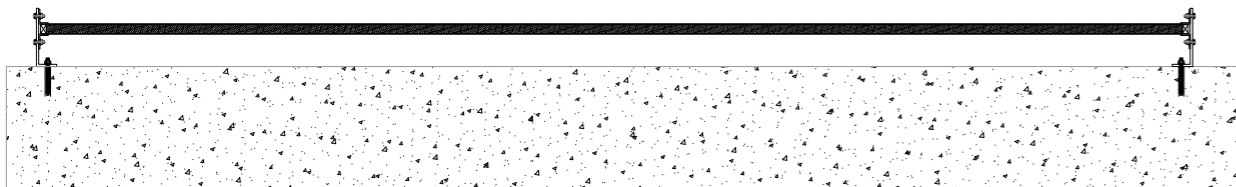
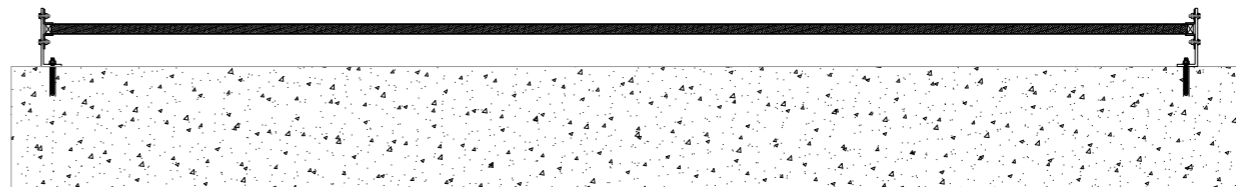
1702-1003 REV P1

1	Test 1	1:20
-	Serviceability, Safety & Cyclic

2	Test 2	1:20
-	Serviceability, Safety & Cyclic

Title			
Test Rig - Panel Arrangement Wind Load Testing			
Cad File Name	Drawn By	Checked	
1702-1000	VERTEKS	-	
Date	Scale	Size	
Feb 25	1:20		A3
Drawing Number			Revision
1702-1003			P1

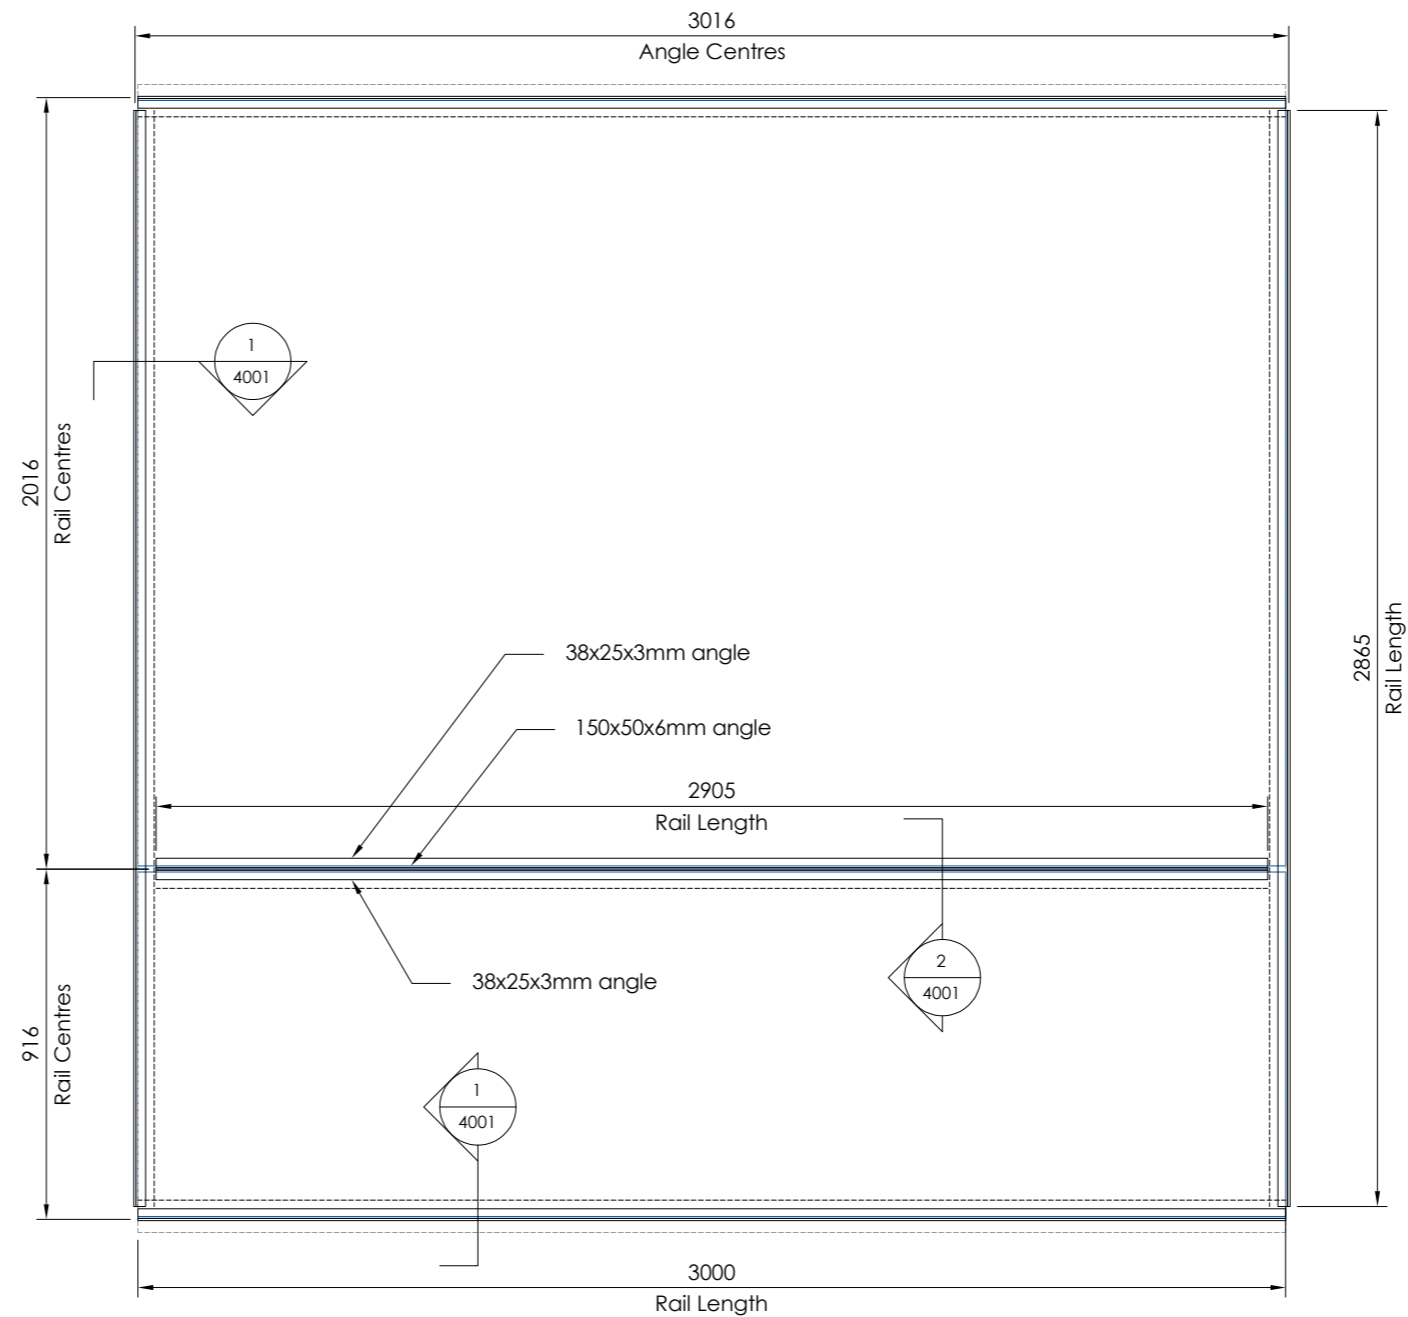
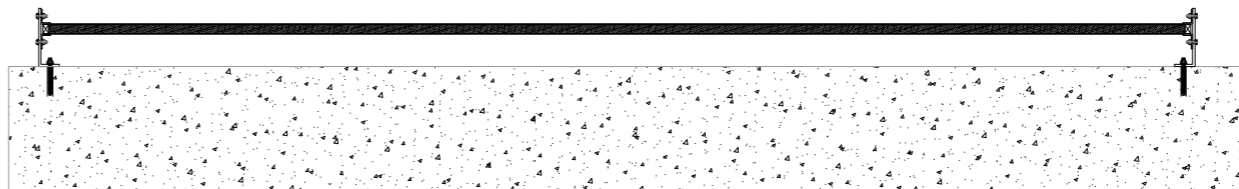
1702-1004 REV P1

Client		
Newbrell		
Project		
Insulated Panels Impact and Wind Load Testing		
Title		
Test Rig - Panel Arrangement Wind Load Testing		
Cad File Name		
1702-1000		
Date		
Feb 25		
Scale
